# Garage A Sinkhole Project Final Report

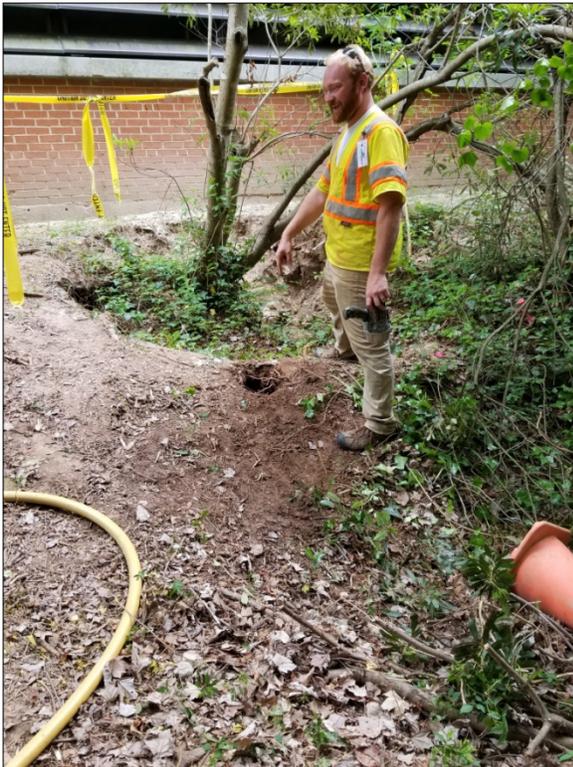
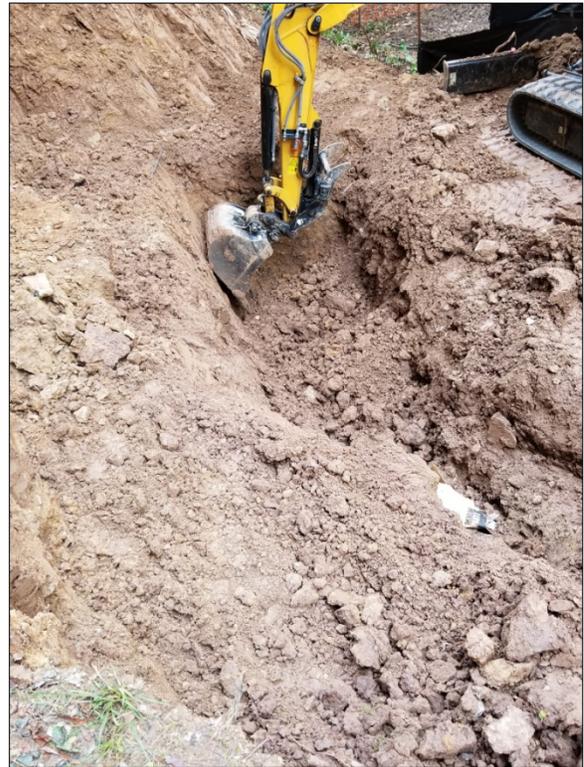
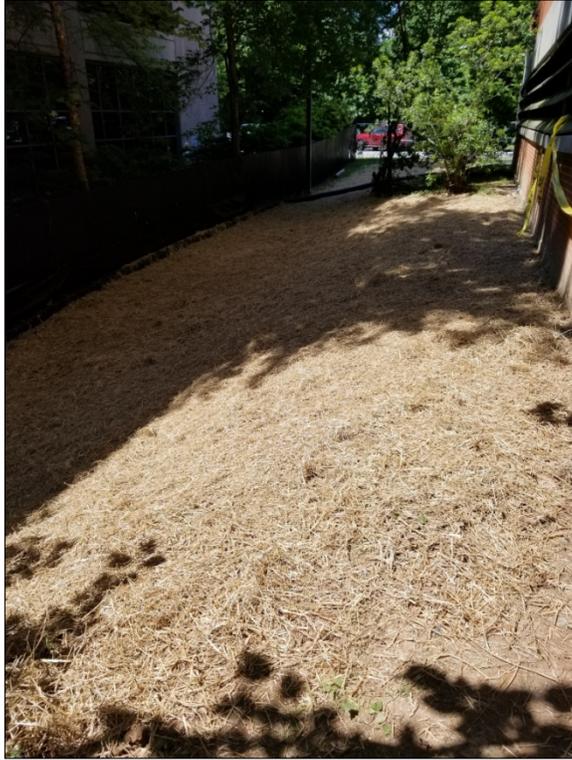
Commencing the week of May 22, 2018, Federal Parking on-site, corporate and project management staff oversaw the repair, replacement and rebuilding stages of the sinkhole. In addition, a Falcon Senior Geotechnical Engineer was on-site to observe, along with the adjuster for Great American Insurance (Engle Martin & Associates), the Raleigh-based engineer engaged by Great American Insurance (Rimkus Consulting Group), and the owner and workers from Durham-based RBS Grading & Excavation. The excavation of, and subsequent repairs made to the observed surface collapse lasted four days, from mobilization and site preparation to final grading after completion of sinkhole re-filling. During this process, NC One Call inspected the uncovered gas lines to designate which gas lines were still active, ensuring that no damage, intrusion or removal occurred by the construction team. The photos below illustrate the initial sinkhole observed, the site during excavation, and the re-graded site.

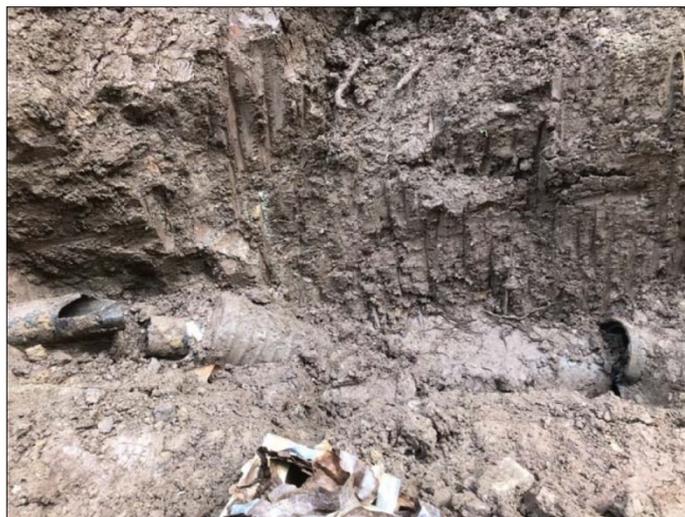
RBS performed the excavation and pipe repair services. Excavation at and below the location of the observed sinkhole confirmed that the partial cause of the sinkhole was in fact a break in the 8-inch roof leader drain pipe, in the general vicinity of its original construction tie-in to the 54-inch reinforced concrete pipe (RPC). This was previously suspected and reported in an April engineering investigation report, and included in the photo below taken during excavations.

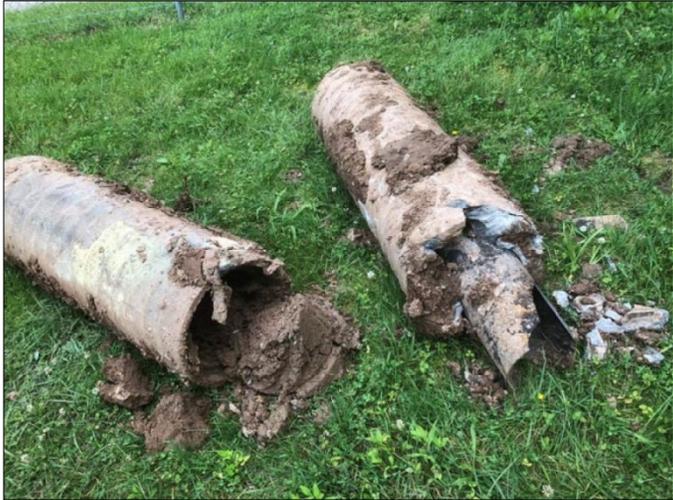
A break in the roof drain pipe was observed within the 8-inch diameter ductile iron pipe (DIP) section just inches before the hard connection to small diameter reinforced concrete pipes (RCP) that had settled multiple inches in two separate, short RCP pipe sections prior to tying into the underlying 54-inch RCP. The two sections of excavated broken and settled pipe sections are shown in the following photo.
